**MARYLAND HISTORICAL TRUST
DETERMINATION OF ELIGIBILITY FORM**

Property Name: Oakland Mills Survey District Inventory Number: HO-1047
 Address: 5509, 5505 and 5471 Old Columbia Pike Historic district: ☐ yes ☒ no
 City: Columbia Zip Code: 21045 County: Howard
 USGS Quadrangle(s): Savage
 Property Owner: Multiple owners Tax Account ID Number: _____
 Tax Map Parcel Number(s): _____ Tax Map Number: HO30
 Project: US-29 from Middle Patuxent River to MD 175 Agency: SHA
 Agency Prepared By: EHT Tracerics
 Preparer's Name: Kate Ritson Date Prepared: 10/16/2011
 Documentation is presented in: MIHP Form
 Preparer's Eligibility Recommendation: _____ Eligibility recommended ☒ Eligibility not recommended
 Criteria: ☐ A ☐ B ☐ C ☐ D Considerations: ☐ A ☐ B ☐ C ☐ D ☐ E ☐ F ☐ G
Complete if the property is a contributing or non-contributing resource to a NR district/property:
 Name of the District/Property: _____
 Inventory Number: _____ Eligible: ☐ yes Listed: ☐ yes
 Site visit by MHT Staff ☐ yes ☒ no Name: _____ Date: _____

Oakland Mills Survey District

other Oakland Mills Survey District

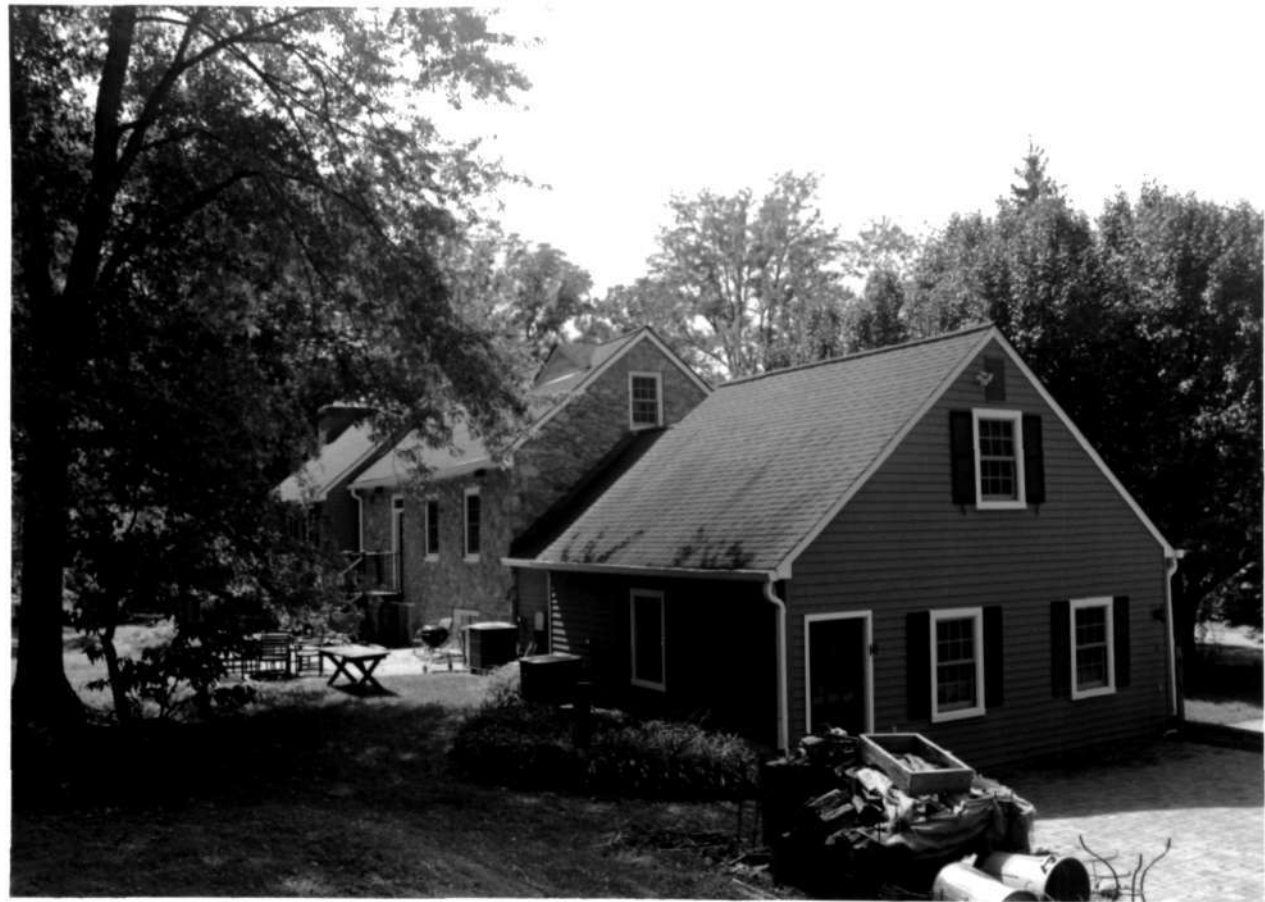
2/13

The north and south (side) elevations of the main building are largely not visible due to the flanking wings. The west bay of the south elevation holds a single window with a splayed stone lintel at its first story. The north elevation is fenestrated at its upper gable end with a replacement window and stone lintel.

Main House, north elevation, looking SW

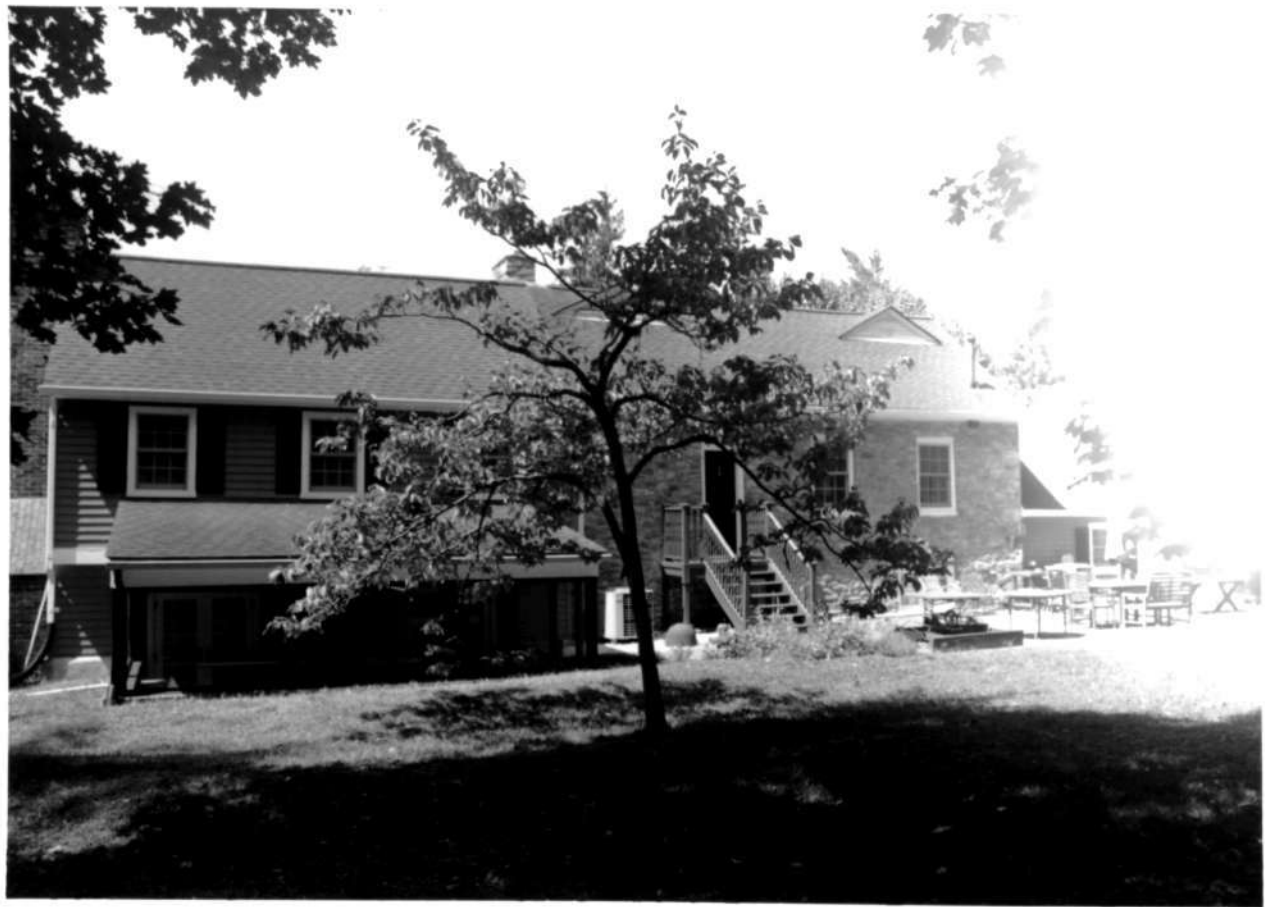
8/13

Due to the building's placement within the property's upward slope, the east (rear) elevation of the original building only displays a single story, which corresponds to the second story of the front façade. In contrast to the façade, the fenestration at the rear of the building is not symmetrical, most likely the result of interior uses and stair placement. The foundation level is pierced by three openings. An entry is located below-grade to the south. Approached by a set of brick steps, the entry is marked by a single-leaf wood door, paneled with six lights. The door is capped by a wood lintel, which extends north to cover a nine-light fixed vinyl window set in a square-edged wood surround with a wood sill. The northernmost bay at the foundation level is pierced by a ten-light fixed wood window, set in a square-edged wood surround with wood sill and surmounted by a brick flat arch. The main story of the building is fenestrated with an entry door in its south bay, centered above the foundation level entry. The entry is approached by a set of wood steps with turned balusters, and the opening is marked by a single-leaf paneled wood door set in a narrow square-edged wood surround and surmounted by a three-light transom and narrow wood lintel. The two north bays of the main story are fenestrated with replacement 1/1 (false 6/6) double-hung vinyl sash windows set in a square-edged wood surround with a wood sill and narrow wood lintel.

Main House, east elevation, looking W

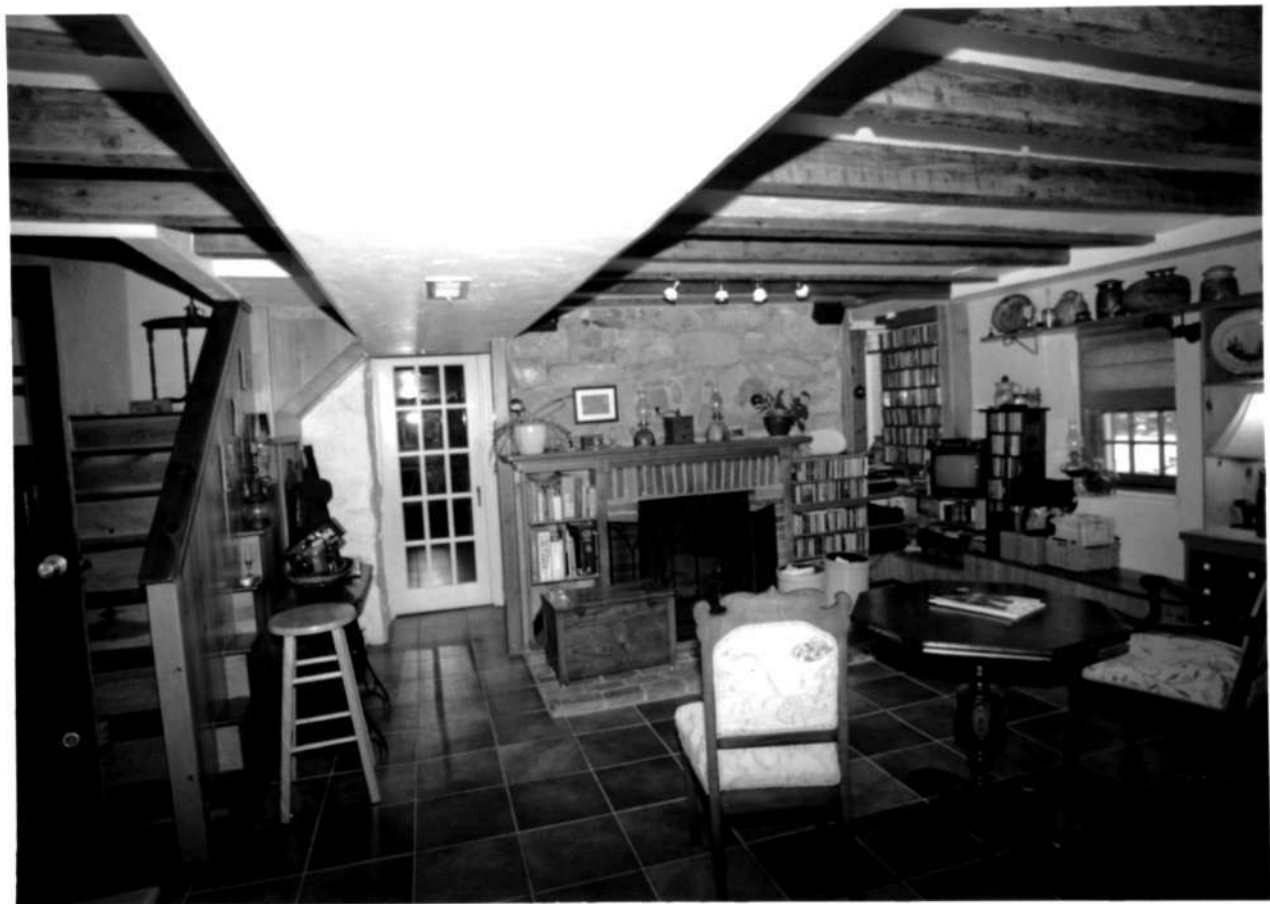
4/130

At the first floor of the original building, the front entry opens immediately into a large, open living and dining area. To the north, a wide, open entryway provides access to a modern kitchen. A small hallway with connecting full bathroom has been added immediately to the east of the kitchen by the current

Main House, Interior, first floor, looking S

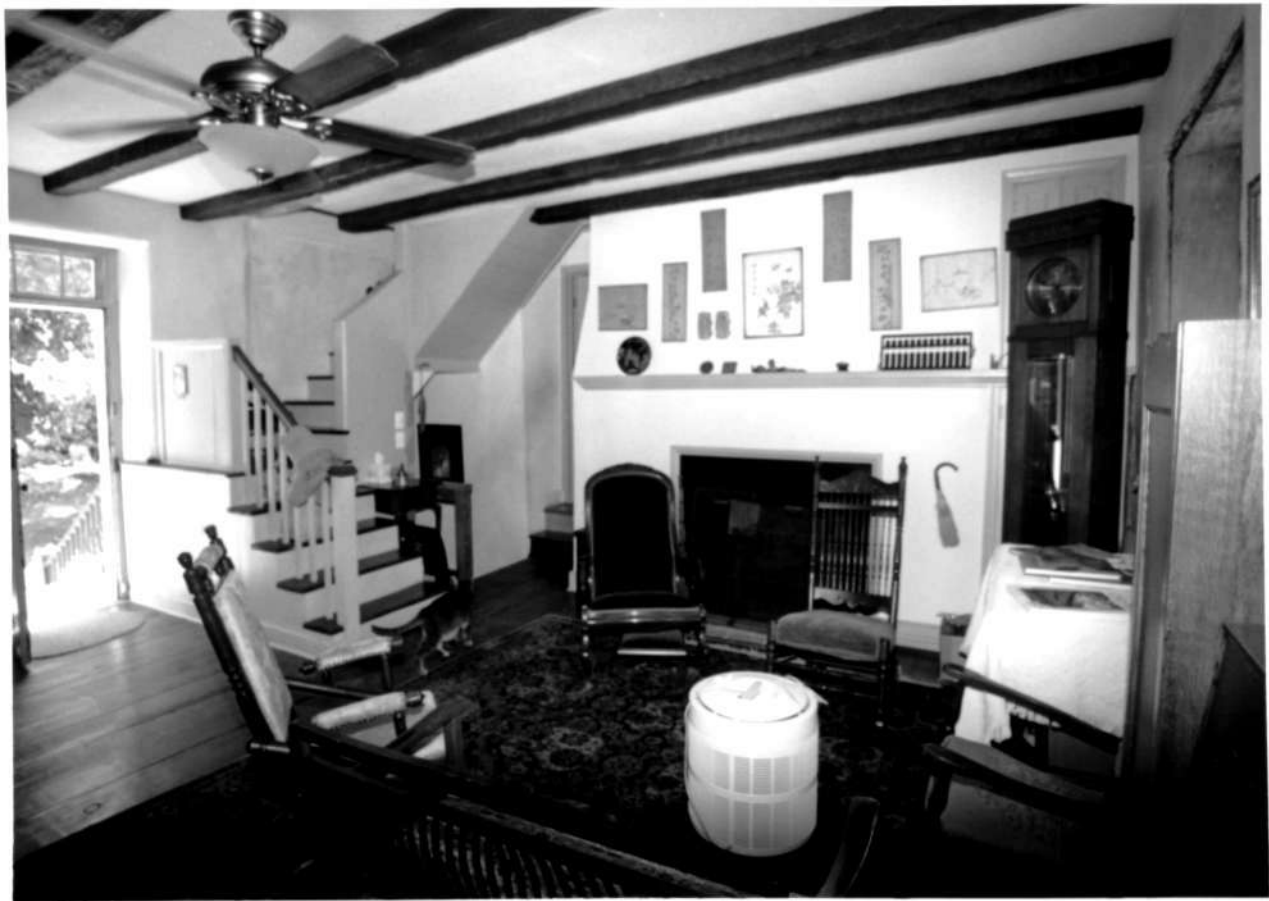
5/13

Access to the second floor is provided at a turned wood staircase, an original feature, in the southeast corner of the living area room. The second floor features a main living area, and a bathroom added to the north, which was added in the 1950s. The space features original wide wood plank floors, the widest board measuring 22" with the average boards measuring about one foot. The door openings hold original but not historic paneled wood doors set in molded surrounds. The fireplace, set in the south wall, is set in a simple plaster surround. Built-in paneled wood cabinets are set to its west, an original feature of the house. The living area is finished with plastered walls with a short wood baseboard with kick molding and exposed wood beams, installed ca. 1950. The modern bathroom is finished with tiled floors, gypsum board walls, and beaded board wainscoting beneath the chair rail.

Main House, Interior, Second Floor, looking SW

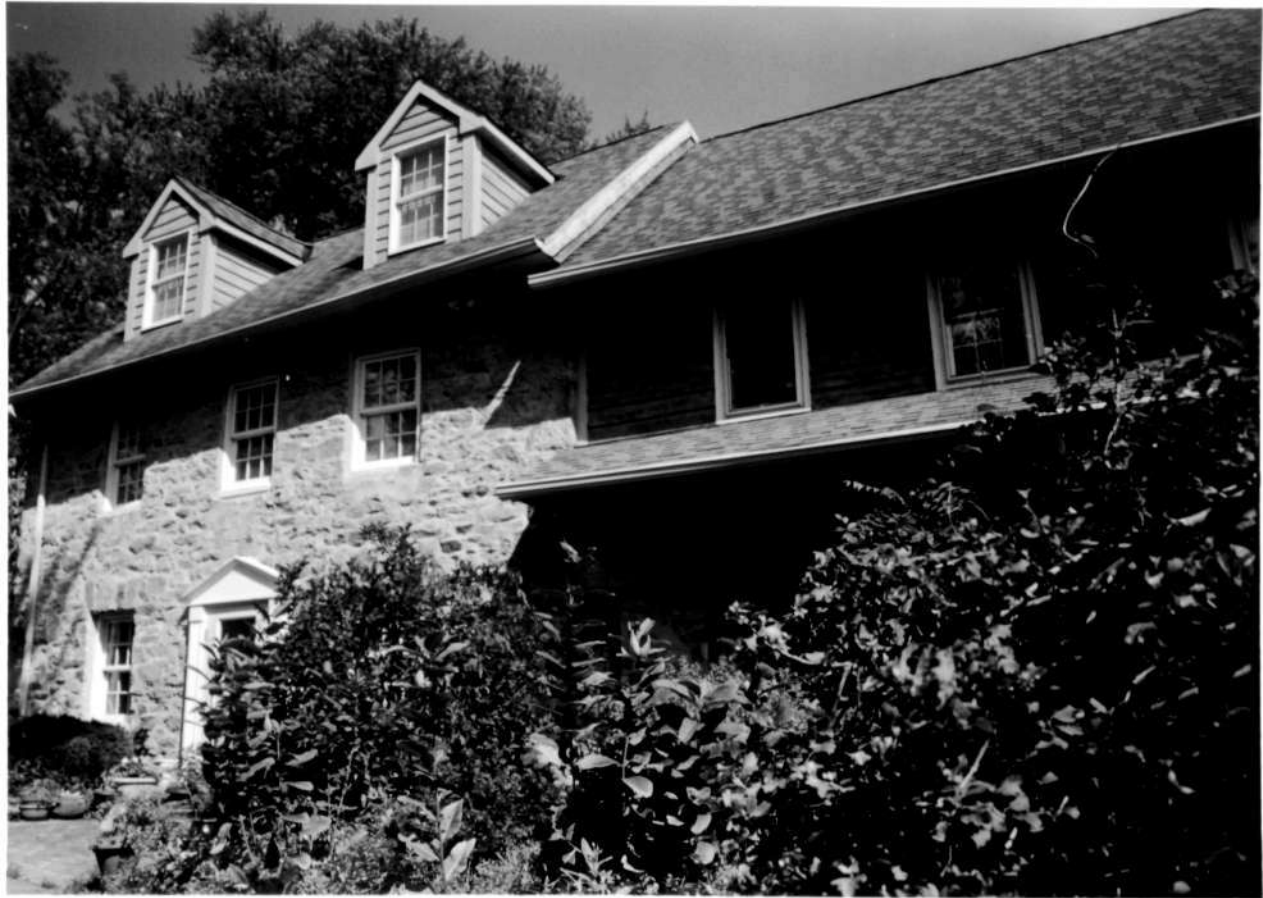
16/13

The original building is two-and-one-half stories high, three-bays wide, and one-room deep. Set on a solid stone foundation, the building's masonry walls are laid in uncoursed random rubble stone. The symmetrical façade (west elevation) is three-bays wide and features a centered entry. The fenestration is arranged noticeably close together towards the middle of the façade. The entry is marked by a replacement single-leaf glass in wood modern door, set in a replacement Colonial Revival-style surround featuring an open pediment and flanked by fluted pilasters with base and corner blocks. The entry is flanked by a window opening to each side, each opening holding a 1/1 double-hung vinyl sash window with 6/6 false muntins.³ Each window is set in an ovolo wood surround with a wood sill and surmounted by a splayed stone lintel which decorative interest to the facade. The second story features three symmetrically placed windows, identical to those at the first story, although their lintels have been obscured by the reconstructed roof. The building is capped with a heavy, steep side gable roof of asphalt shingles that is

Main House, west elevation, looking NE

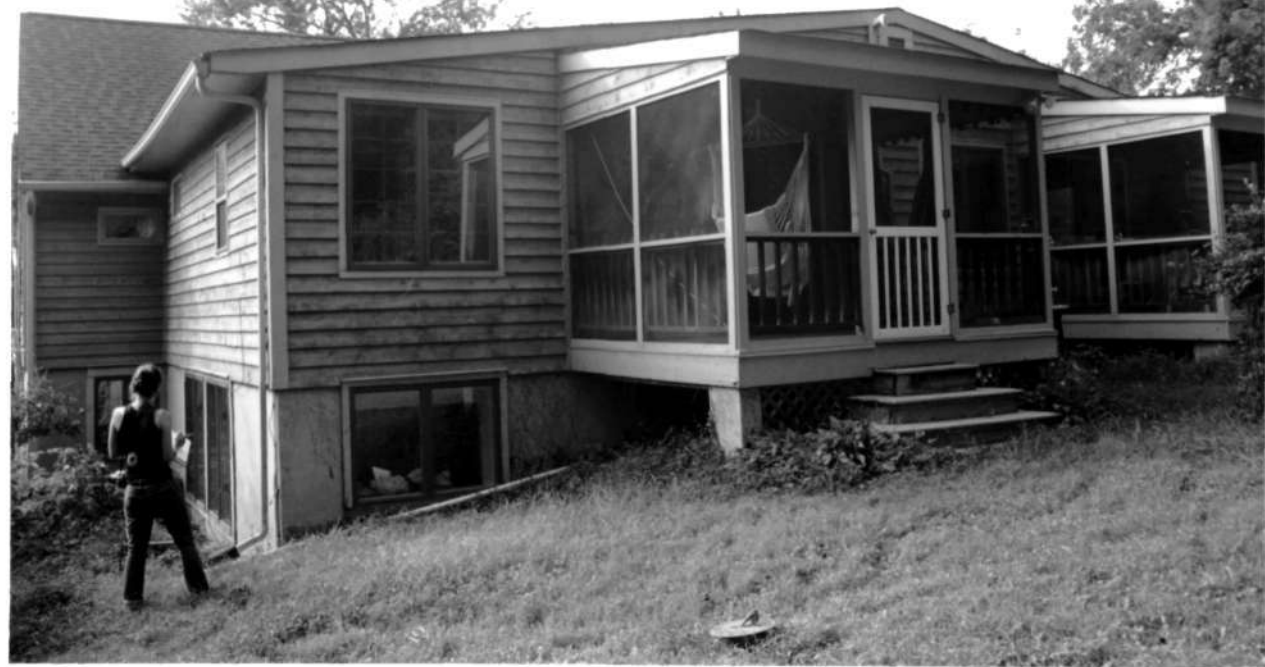
8/13

The rear (east) elevation of the original building is completely obscured by a rear addition, as noted. Set on an exposed concrete foundation, the addition is constructed of wood frame and is clad in wood weatherboard. It is set beneath a shallow front gable roof covered in asphalt shingles. Two identical screened, frame porches with asphalt shingle shed roofs extend from the elevation. Approached by short sets of wood steps, the porches are set on concrete pier foundations and are constructed of wood. Each porch encloses a rear entry, marked by sliding glass metal doors at the addition's elevation. The foundation of the rear elevation is marked by two six-light metal casement windows, and one two-light

Main House, east elevation, looking NW

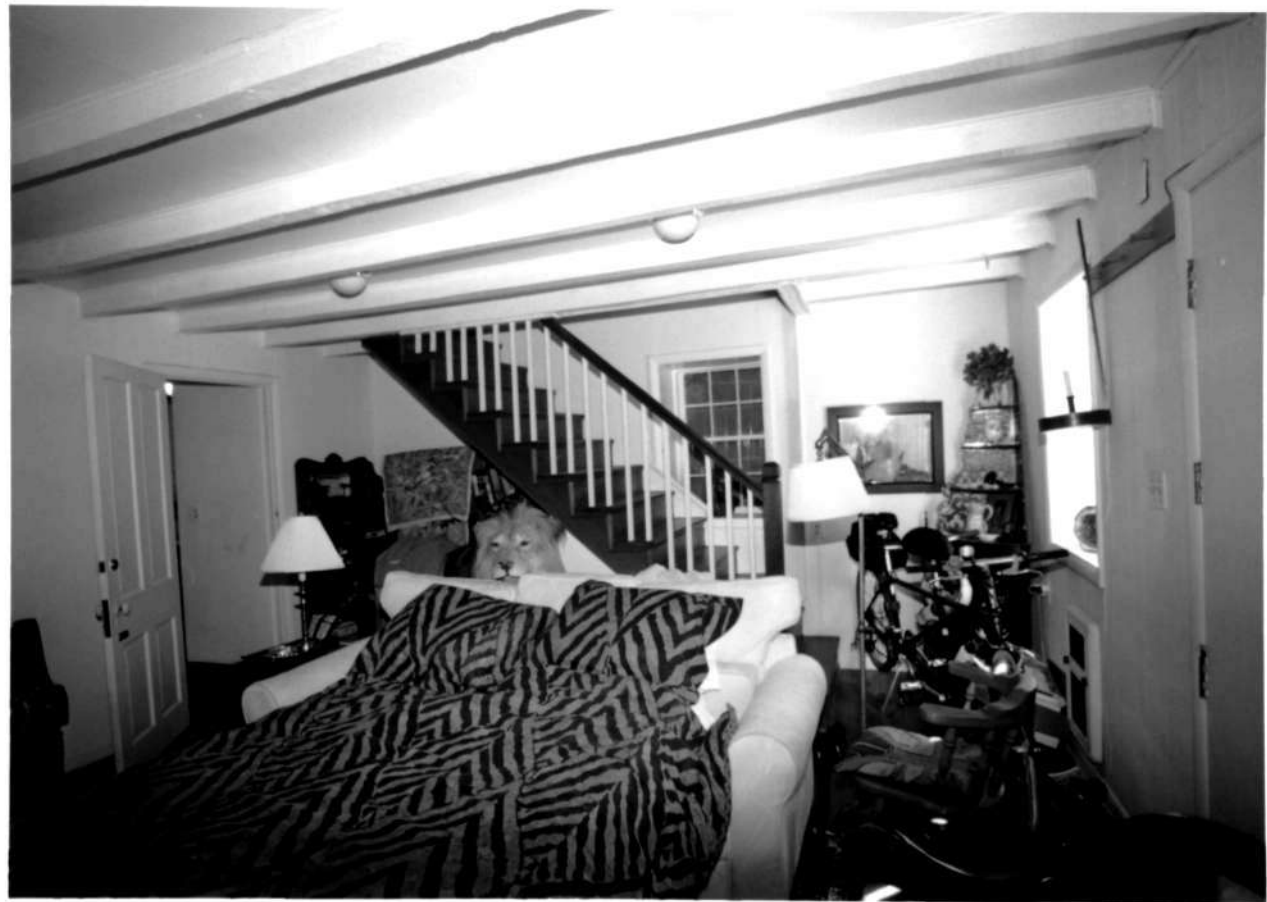
9/13

Access to the original building is provided through a central front entry door. The entry opens directly into what is currently a living room. The floors are finished with 4" wood plank (the flooring was installed in the mid-twentieth century by the previous owners, Timothy and Alyce Gales, the room had a dirt floor), the ceilings with exposed, painted beams (also replacement from the 1950s) and the walls are now clad in 7" vertical bead board paneling. The fireplace at the north wall has been refinished with replacement stone. West of the fireplace remains an older paneled wood door to a closet space. An historic but not original 6/6 double-hung wood sash window is set in the south wall, now enclosed by the mid-twentieth-century south addition. At the interior, the two west (front) windows feature deep sill ledges.

Main House, Interior, first floor, looking S

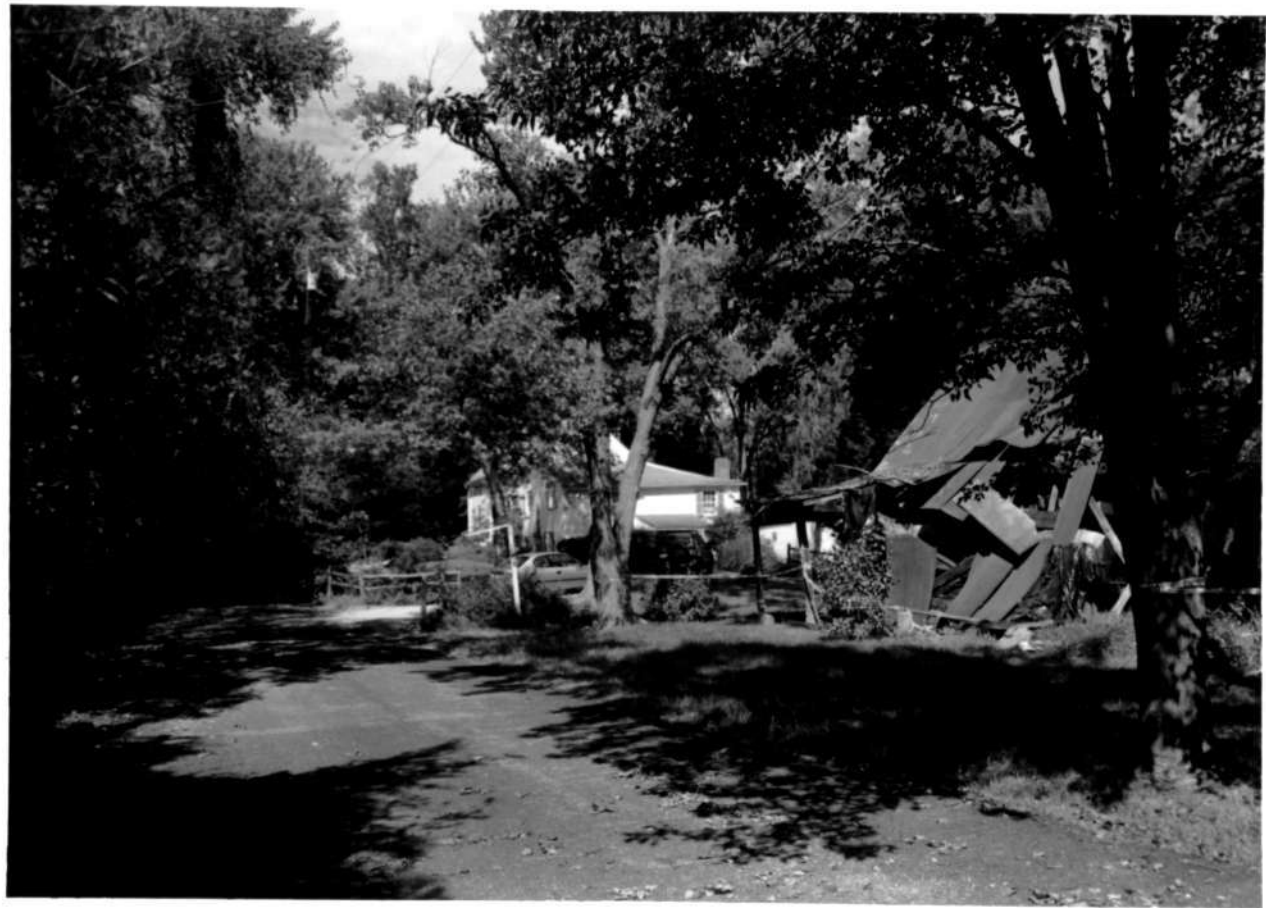
251-6
12/13

The one-story, wood frame blacksmith's shop is located to the south of the main dwelling. The shop was built in two sections, both standing one-story high and capped with a side gable roof of corrugated metal. Set on a low, rubble stone foundation, the building is constructed of wood frame with clad in board-and-batten siding. The floor at the interior is dirt. The front (west) elevation of the shop is marked by a number of large, double-leaf doors constructed of tongue-and-groove beaded wood panels. The doors are attached by hand-wrought iron strap-hinges. A one-story, shed roof porch extends across the width of the façade, but currently, its entire southern half has collapsed. The north, south and east elevations are fenestrated with historic 6/6, double-hung wood sash windows.

Main House and Blacksmith Shop, looking N
